Roof Curb Service Bulletin - 10-11-2011

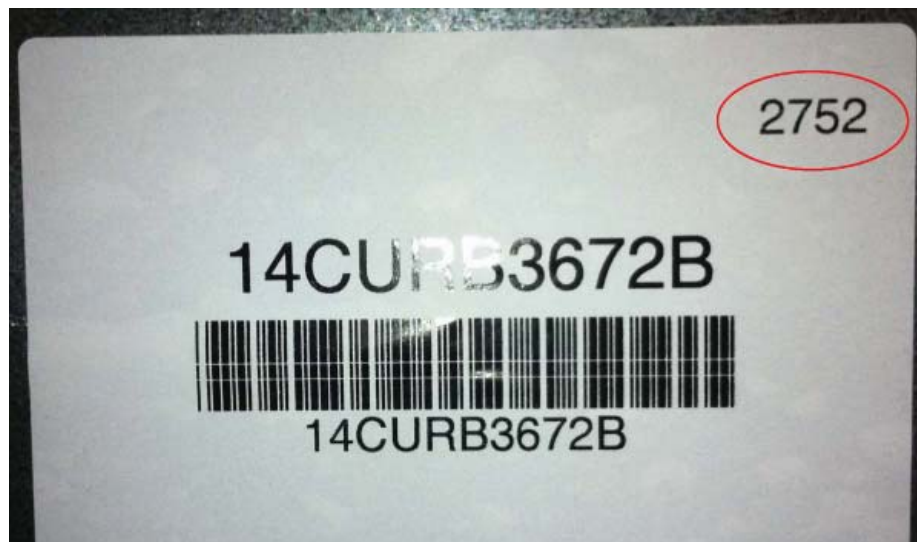
On the curb label is a job number (circled below) that may help in determining if current inventory is affected. The photo below depicts the location of the job number and the table that follows identifies the job numbers that are present on the flawed curbs.

14CURB3672B	14CURB90150	14CURB180240	PGC101/102/103
2471	2494	2497	2495
2547	2619		2618
2602	2696		
2697	2731		
2752

McDaniel Metals is currently in the process of re-manufacturing the narrow sides with proper notching for replacement in the parts where the defect is present. We propose that, rather than cut the bands on the curbs and replacing the defective parts, we build and send correct sides separately that can be included with the entire curb package at the time of sale with explicit instructions to discard the parts included with the curb in favor of the replacement sides. In places where a great deal of defective inventory is present we would send replacement inventory and provide advice on how to return the incorrect parts to McDaniel Metals at our expense.

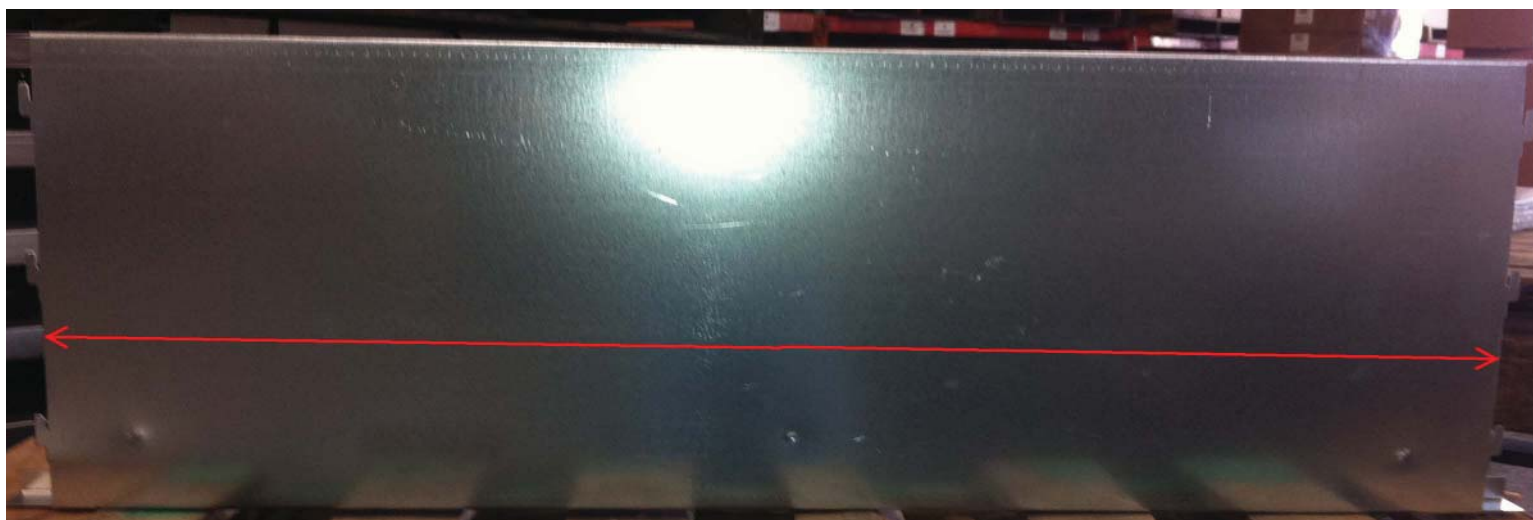
A measurement may also be taken in the location depicted in the second photo of the side with the 'hooks' to determine if the part is defective as well. Please see the accompanying table for the correct measurements.

*The inside dimension of the part should equal the dimension in the **Correct** column below.

Item Number	Incorrect	Correct
14CURB3672B	37 3/8	37
14CURB90150	50 3/8	50
14CURB180240	75 1/8	74 3/4
PGC101/102/103	39 3/4	39 3/8
